Manhole Inspection Summary

Manhole # S17A1_021MH

Insp Date: **6/13/08 12:11 PM**

Location Address: **parksley av**

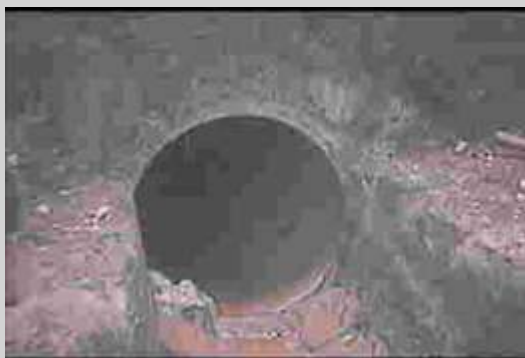
3 O'Clock Inflow

8 in. Circular Gravity Sewer
Pipe In @ 3 O'Clock

Pipe Height: **8.4** (in.) Rod and Bar (Angled)
Pipe Material: **Clay** ☐ Pipe Lined
Invert Depth: **9.81** (ft.) Flow Characteristics: **Slow**
Deposits: ☒ None ☐ Mud ☐ Sludge ☐ Debris ☐ Grease
Silt Depth: **0** (in.) Deposits Extent:
Infiltration: **None** Pipe Seal Cond: **Sound**
